# Rehabilitation of Reinforced Concrete Port Infrastructure that Implements Corrosion Mitigation to Improve a Structure's Service Life

Brian Pailes, PhD, PE, NACE CP-4

Vector Corrosion Services

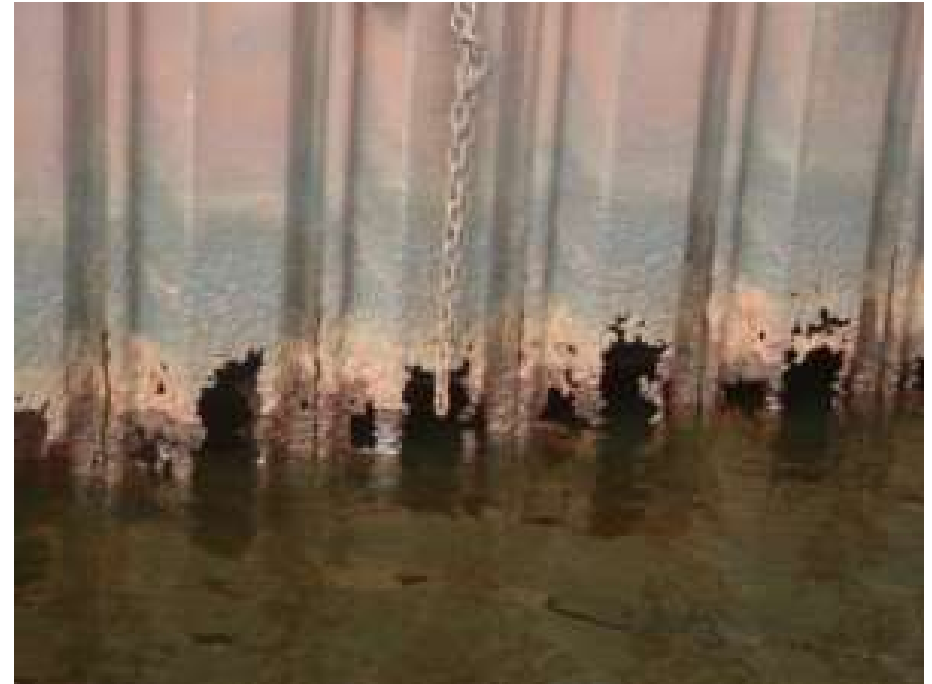
# Steel Structures

- Directly exposed to environment
- Primary factors affecting corrosion
  - pH
  - Temperature
  - Moisture
    - Wetting drying cycles
  - Ion content
    - Chlorides, sulfates, etc.
  - Oxygen Content
  - Water Velocity
  - Coating quality

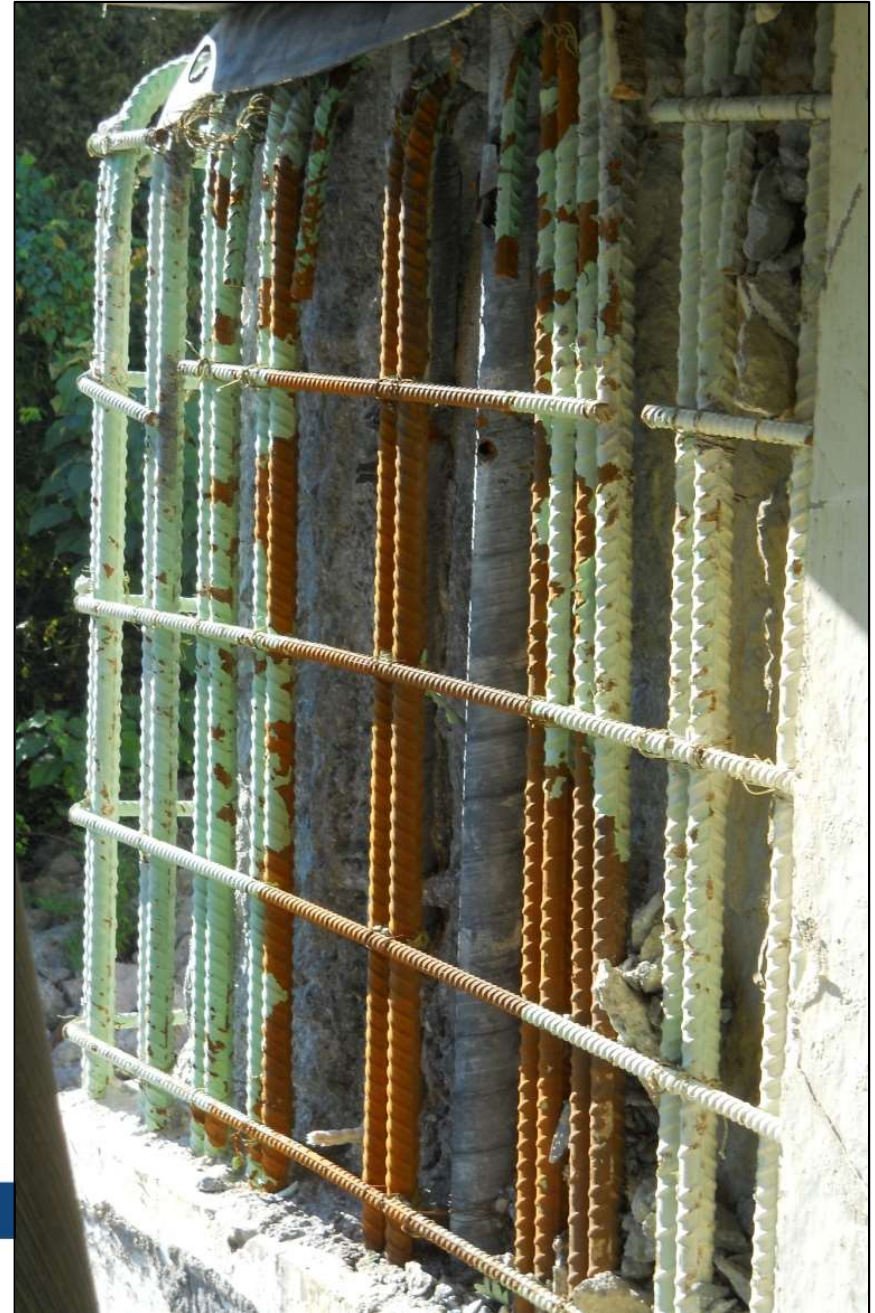
Concrete is naturally alkaline  
pH of about 13

Steel is naturally passive at this  
alkalinity

Formation of passive layer

Passive layer can be destroyed by;  
Chlorides  
Carbonation

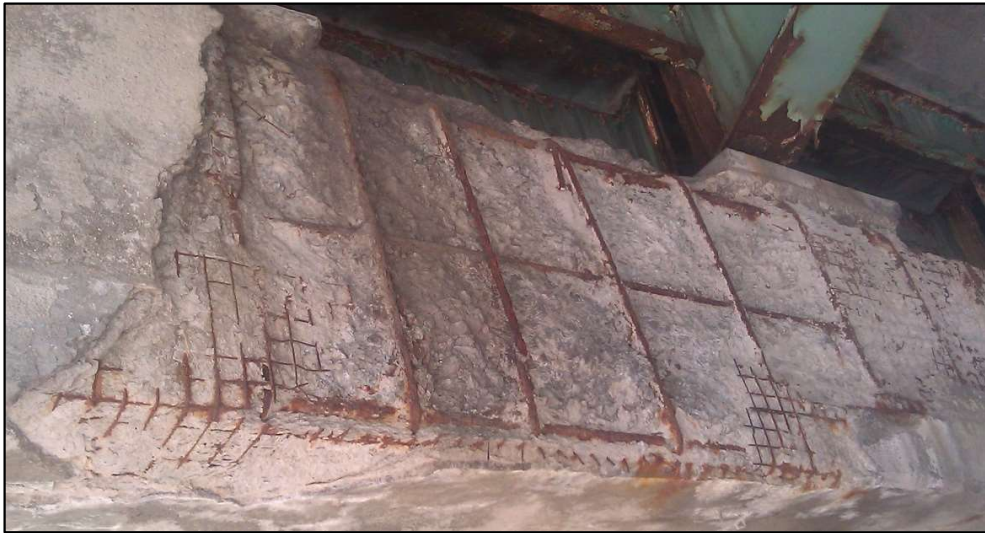
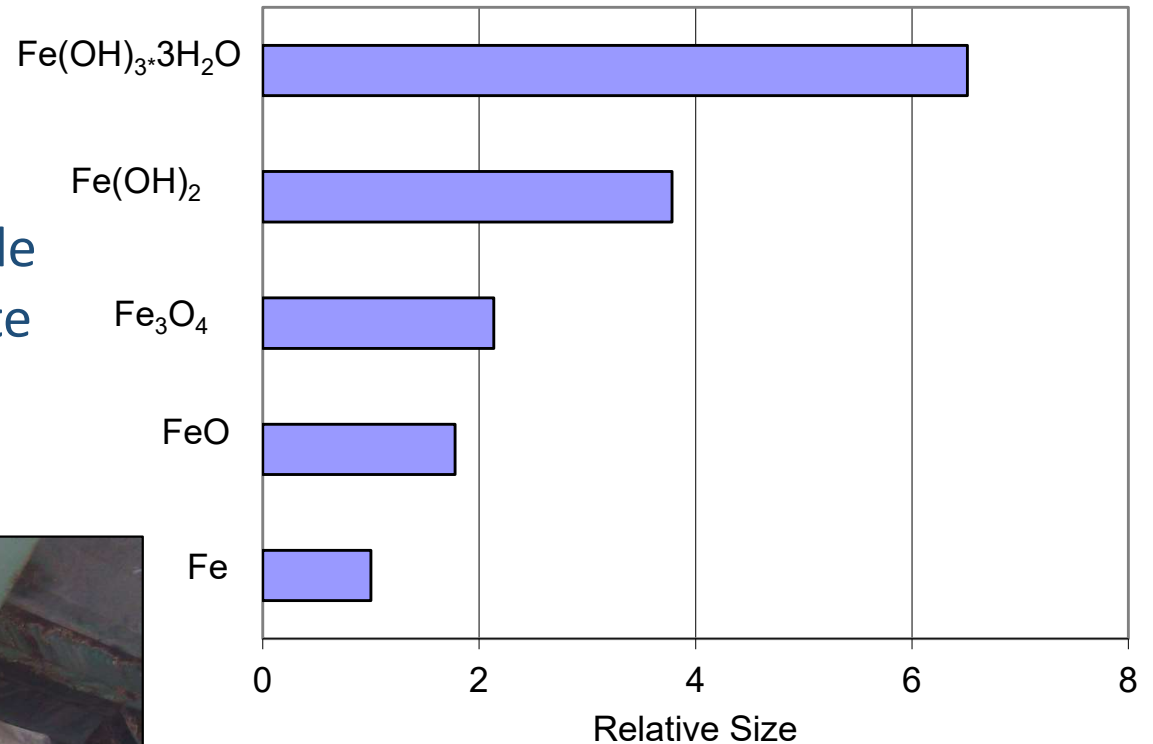
# Corrosion Induced Damage

- Damage resulting from
- Metal section loss and
- Formation of iron oxide (rust)
- Expansive properties of iron oxide create tensile stresses in concrete
- Leads to cracking, delamination, and eventual spalling

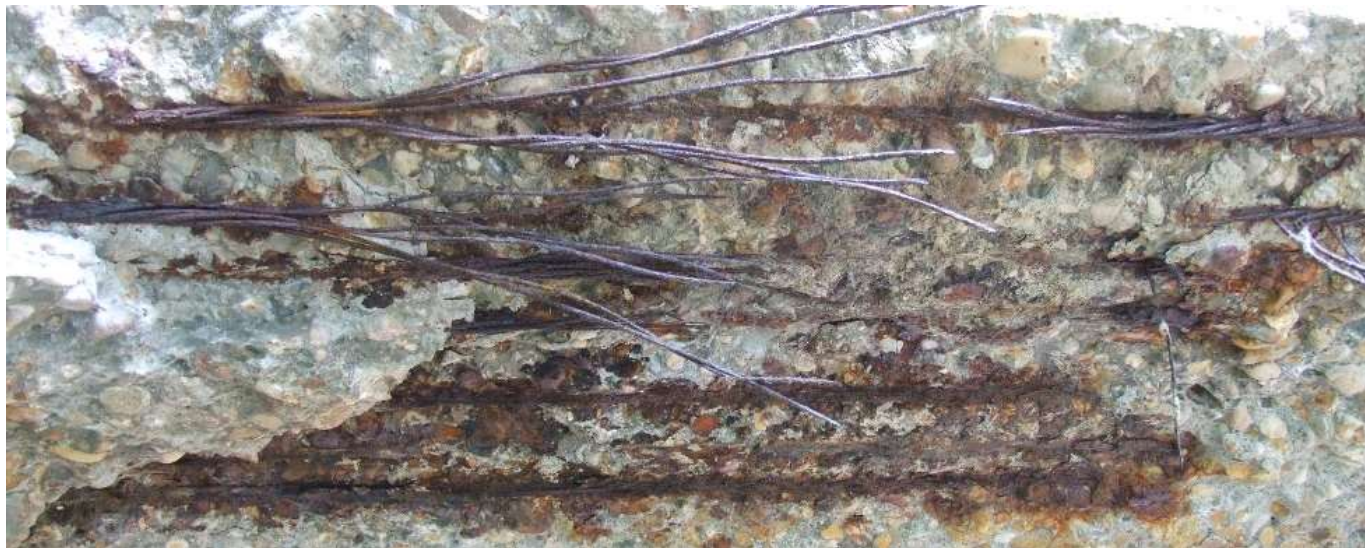
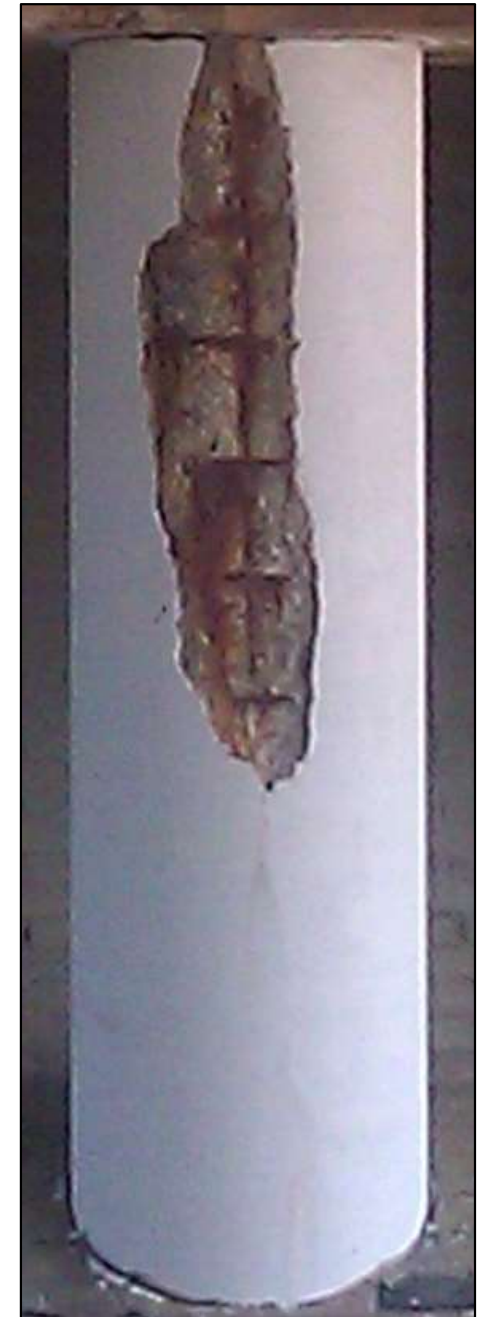
# Corrosion Damage

## Conventional mild reinforcing bar

In most cases loss of steel section not primary concern  
Typically damage to concrete becomes significant and observable prior to severe section loss

## High Strength Tendons

Minor section loss of steel can have significant effect on strength  
Steel can have significant section loss without significant concrete damage

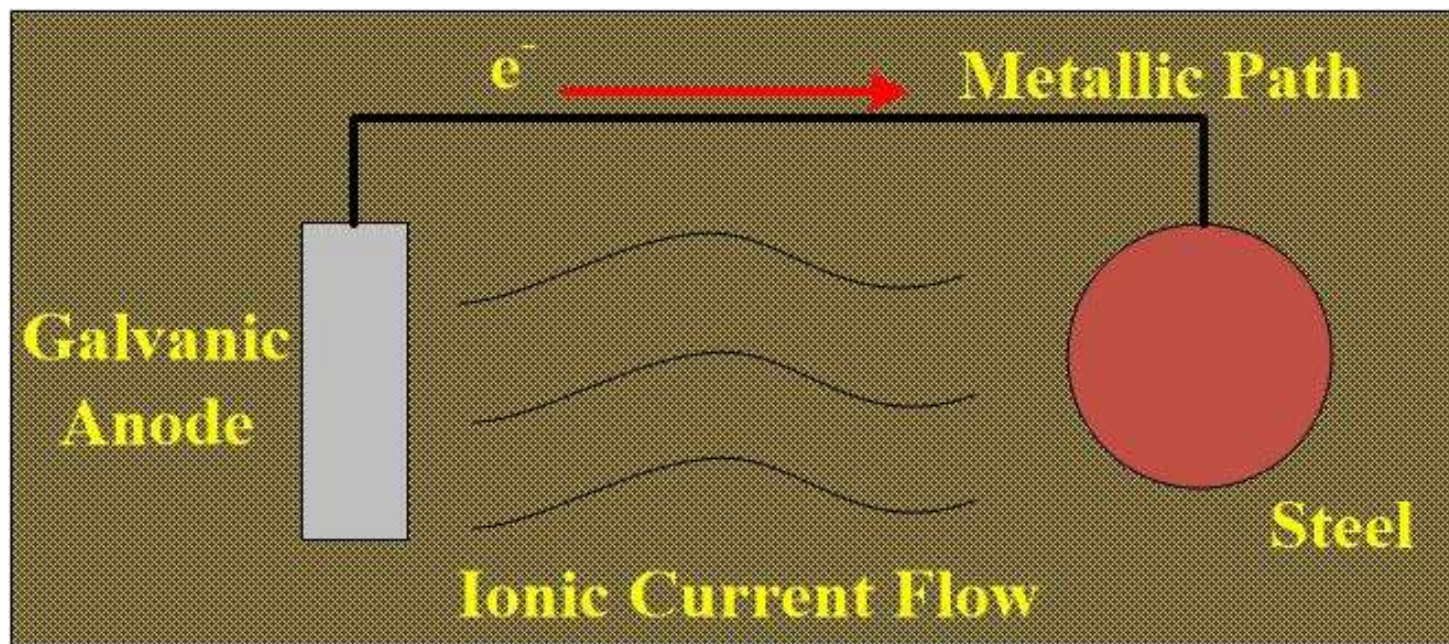
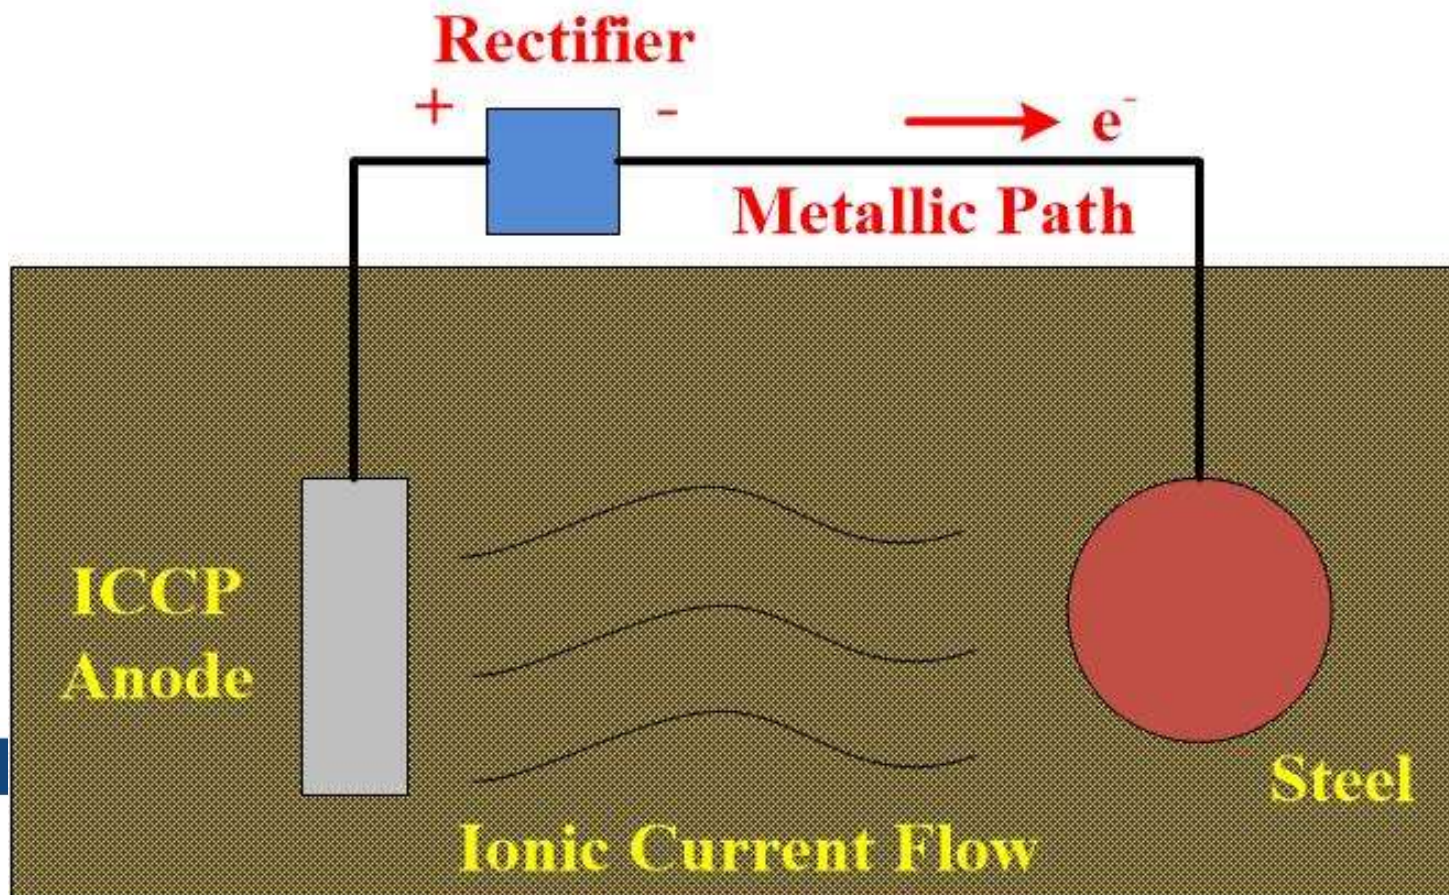
# Cathodic Protection

- Cathodic protection (CP) is a method of corrosion control through the application of direct current to a metal under protection, forcing it to become a cathode
  - Anode is where rust occur and the cathode is protected from section loss
- Two main types of CP
  - Galvanic
  - Impressed current

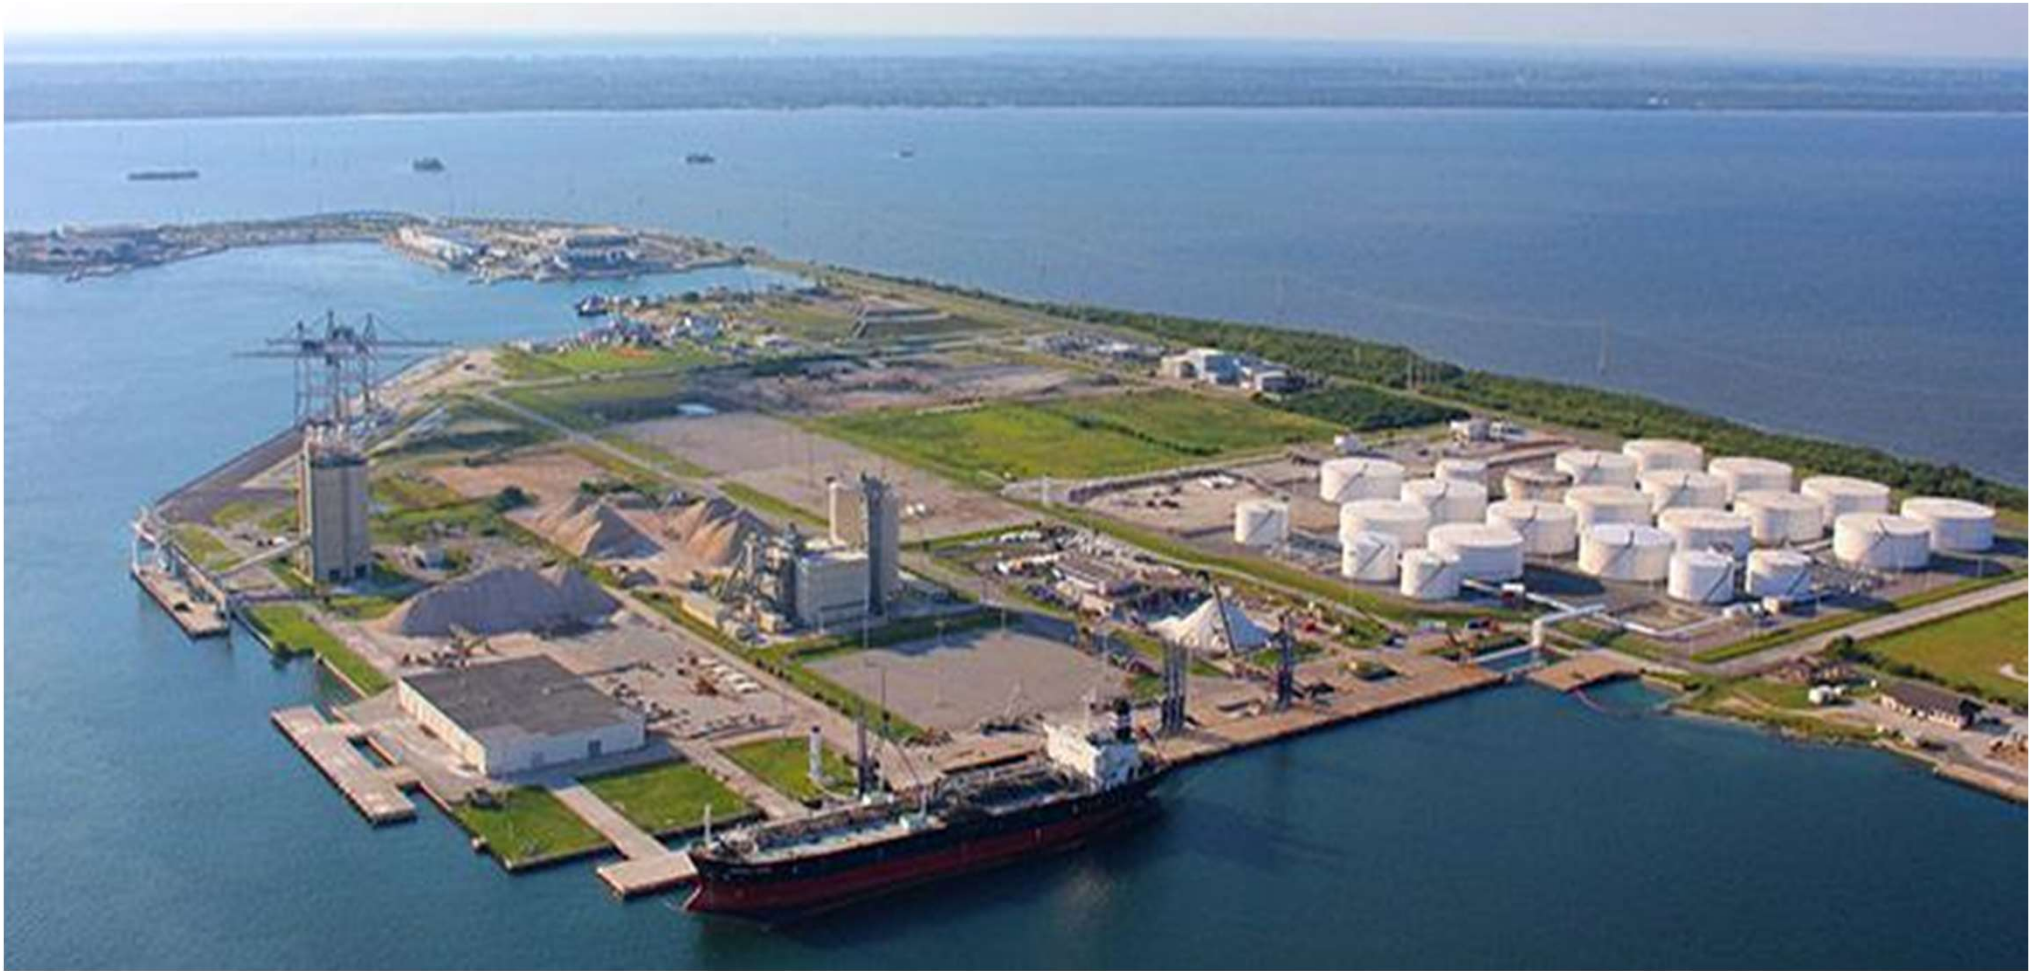
# Port of Canaveral North Cargo Pier Repairs

The North Cargo Piers at the Port of Canaveral consist of four wharves that handle bulk cargo such as cement, slag, salt, automobiles, and lumber. Each wharf consists of square prestressed concrete piles, cast-in-place concrete pile caps and beams, and prestressed hollow-core deck units with a cast-in-place topping slab.

After years of exposure to the corrosive saltwater environment, a major rehabilitation was conducted

concrete deck units were protected using activated arc sprayed zinc applied to the deck soffit.

Over the last 10+ years, the North Cargo Piers have continued to be subjected to the corrosive marine environment and the portions of the structure that were repaired and received the galvanic cathodic protection are showing no signs of corrosion-related deterioration. Other areas which were not repaired and protected have continued to deteriorate and are now in need of repair. Accordingly, the repairs and cathodic protection systems are meeting the owner's goals of providing a long-term, operator-free, maintenance-free protection to the piers in the Port.

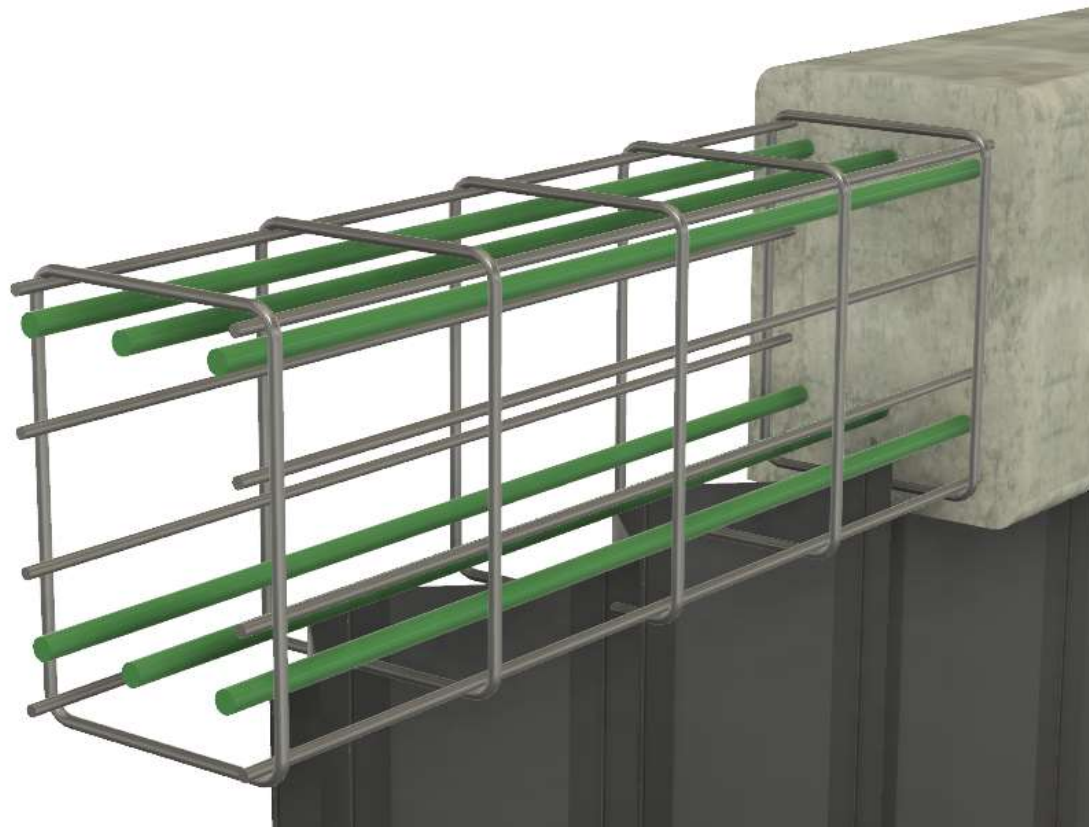
1 SECTION  
17097-08

ALL ANODE CONNECTION TO REINFORCEMENT TO BE PER SPECIFICATIONS AND MANUFACTURER INSTRUCTIONS.

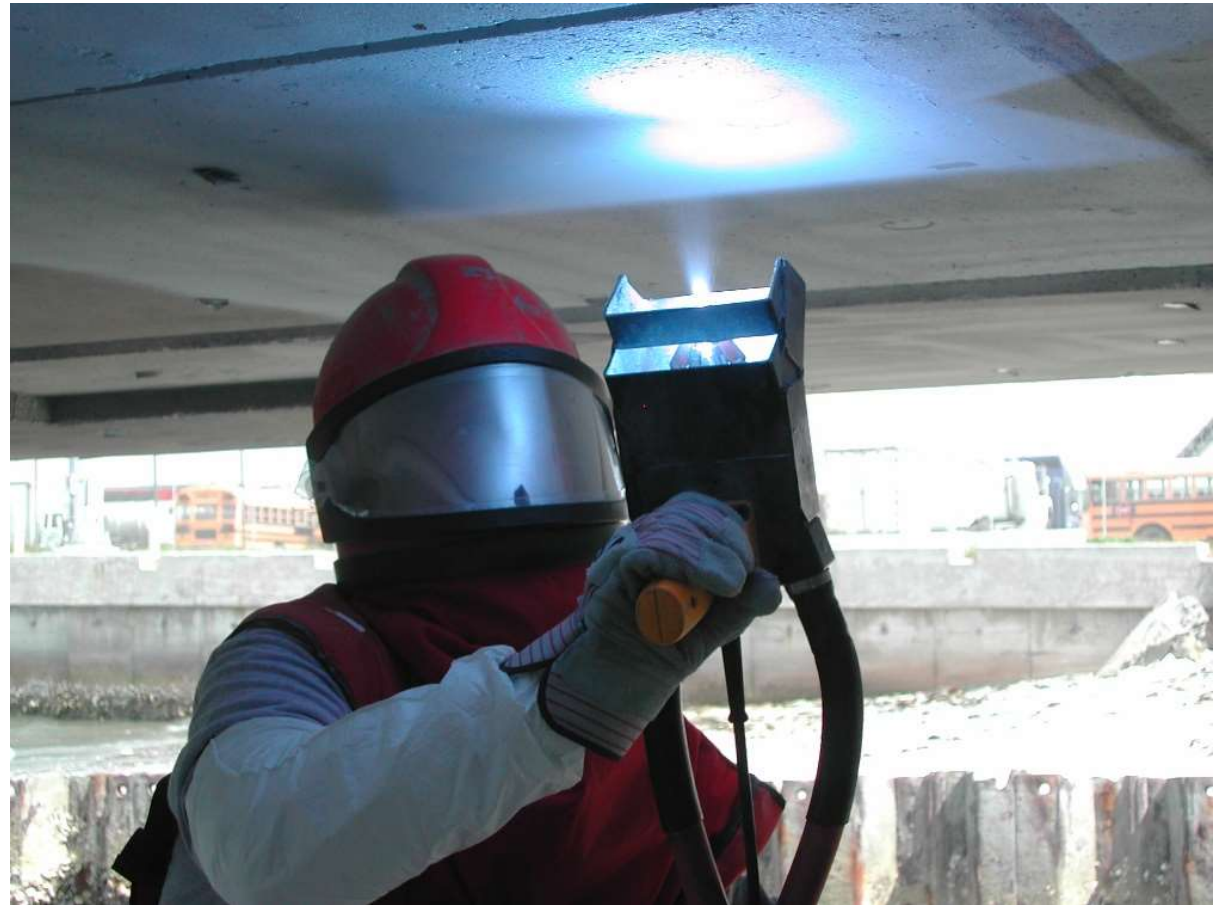
# Arc Spray Surface Applied Galvanic Anode

- Molten Zinc
- Surface Applied
- Multiple passes to reach desired thickness

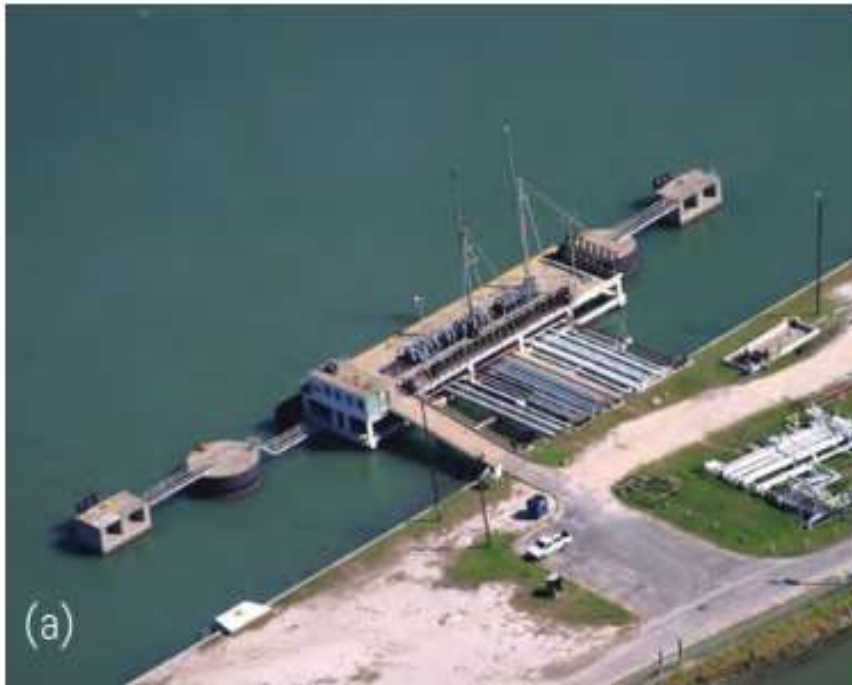
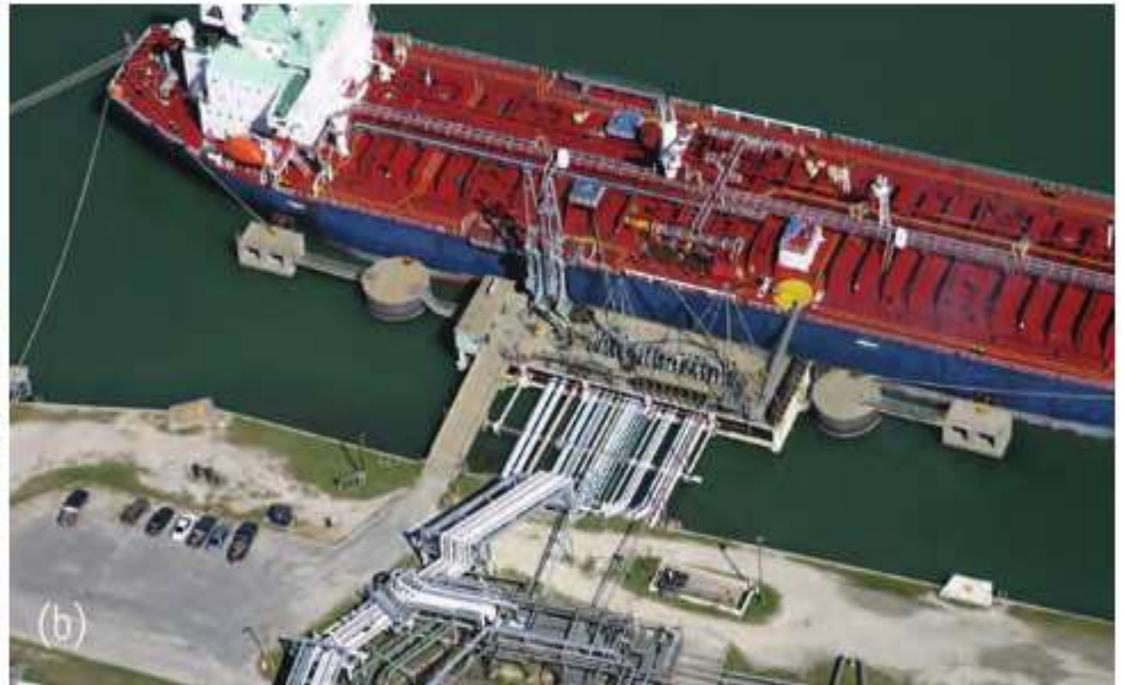
Fig 1: Aerial view of a) Oil Dock 7 and b) Oil Dock 4

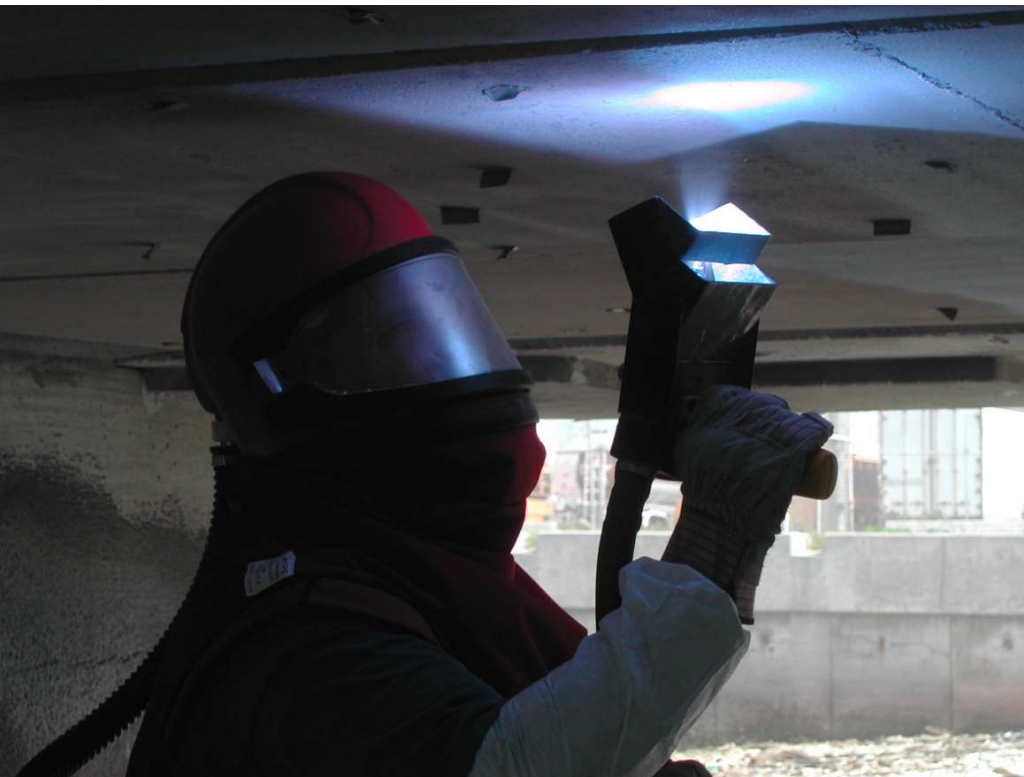
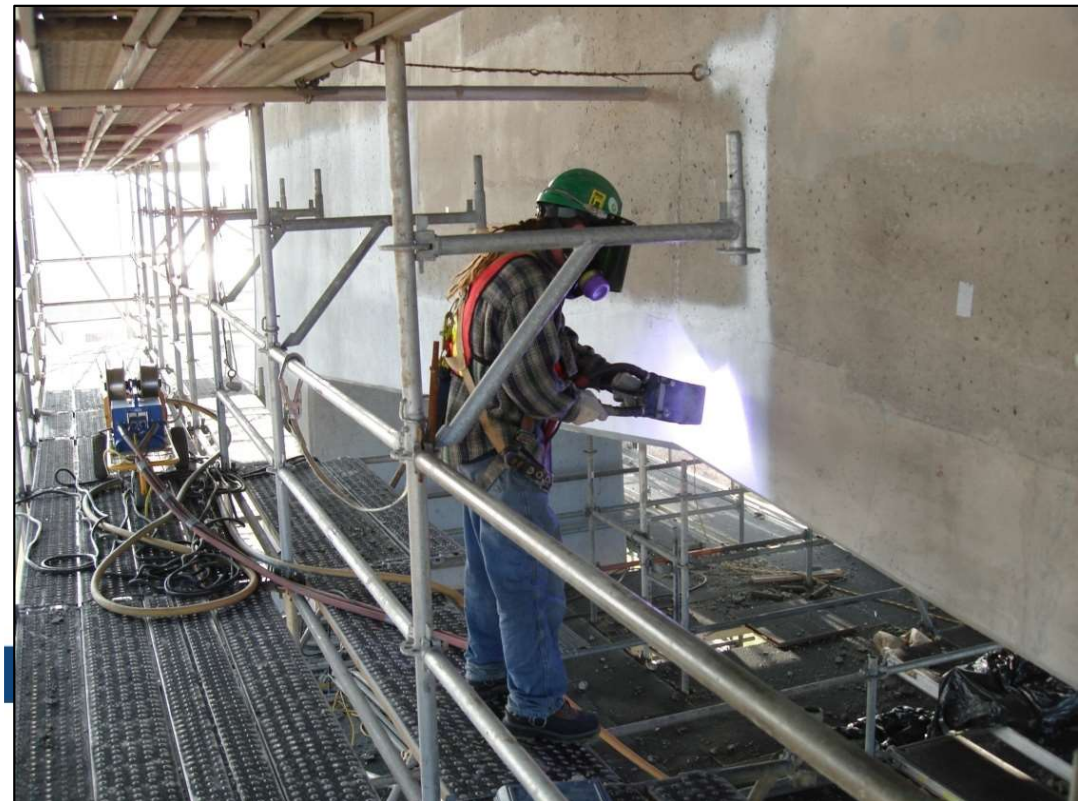
# Original repairs

- Original plans requested zinc metalizing as the cathodic protection system
- Zinc metalizing requires sand blasting the concrete surface then arc melting and spraying of zinc onto concrete surface.

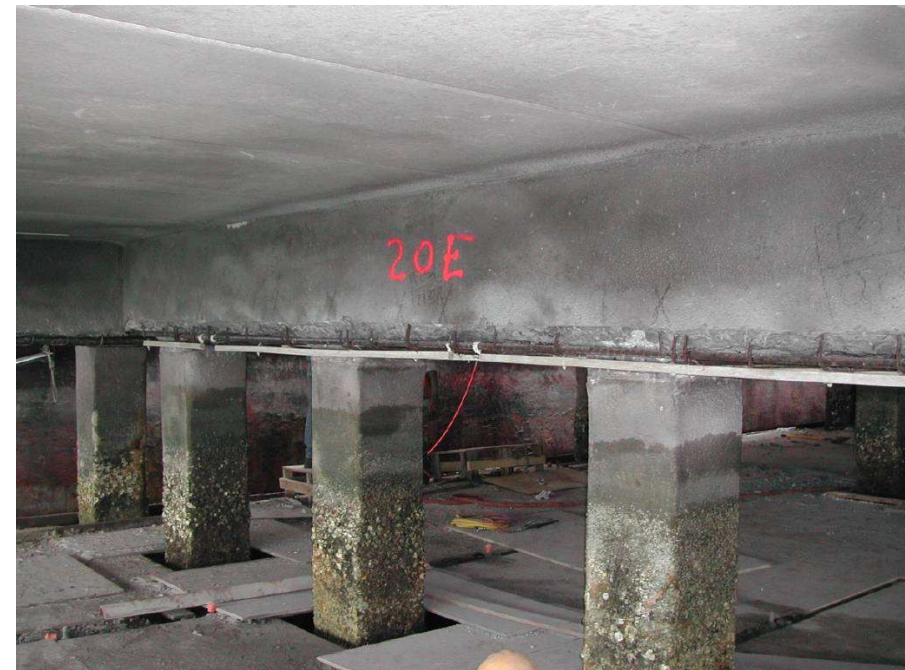
# Why So Expensive?

- Zinc metalizing is almost all hot work
  - Sandblasting of concrete surface
  - Arc spraying zinc
  - Drilling into concrete to make connection
- Prep work can be lost due to an outage
  - Must metalize area same day it is sandblasted
  - If delayed light brush blasting is required before metalizing
- Environmental controls

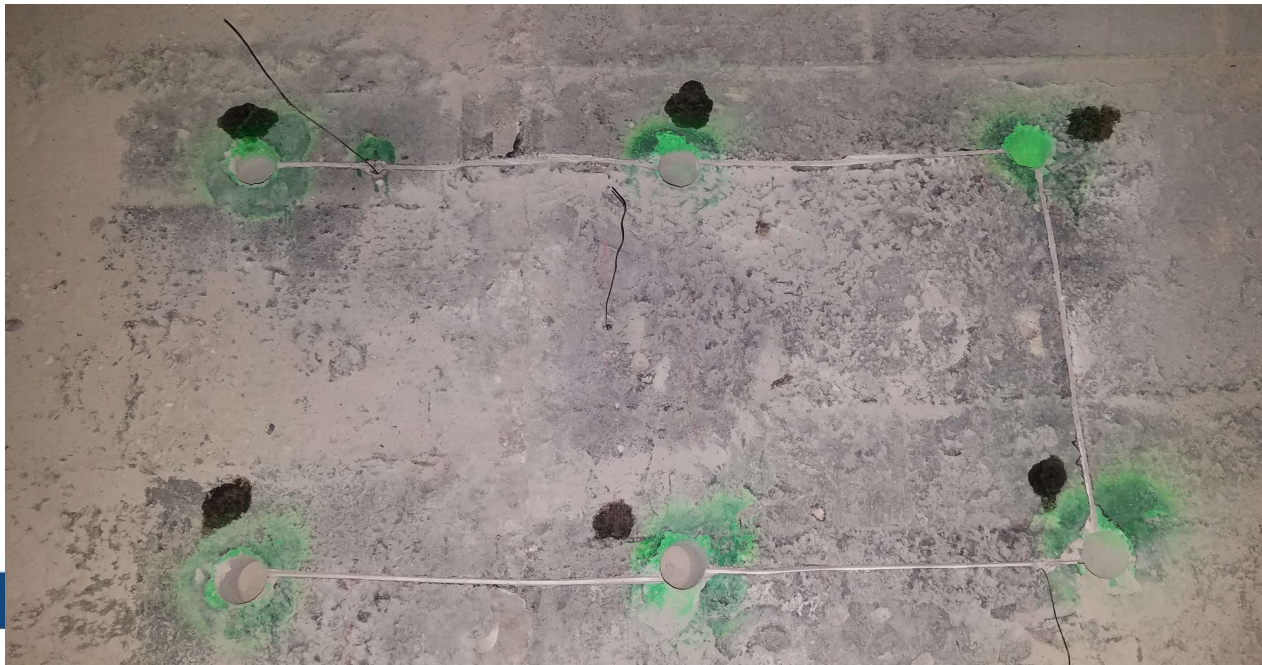
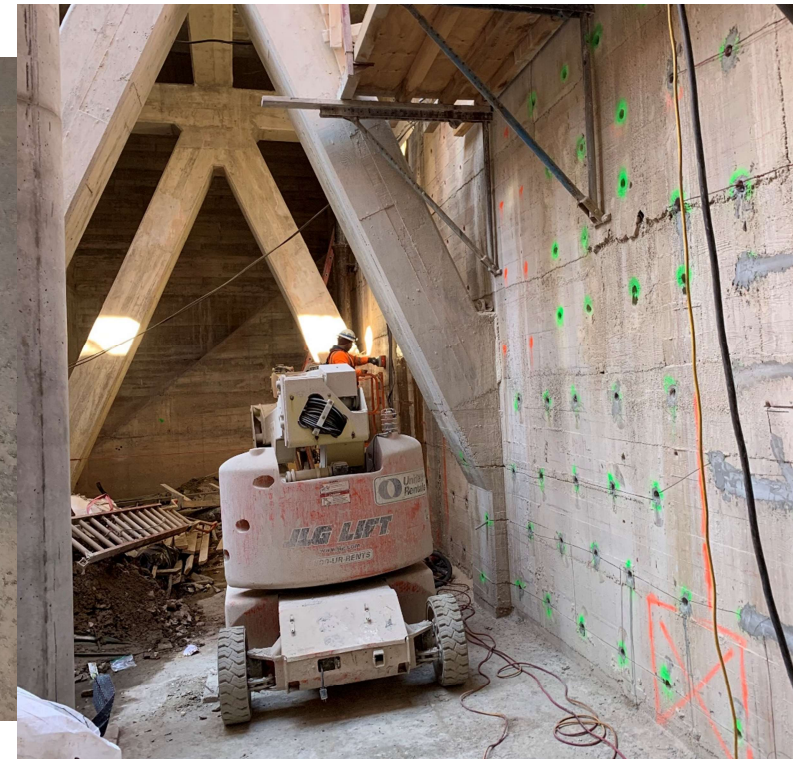
# Drilled in Galvanic Anodes

- To reduce the project budget how can we better utilize days where hot-work was not allowed?
- Drilled in galvanic anodes
  - Still require hot-work, drilling and cutting concrete
  - But grouting of anodes can be done during outages

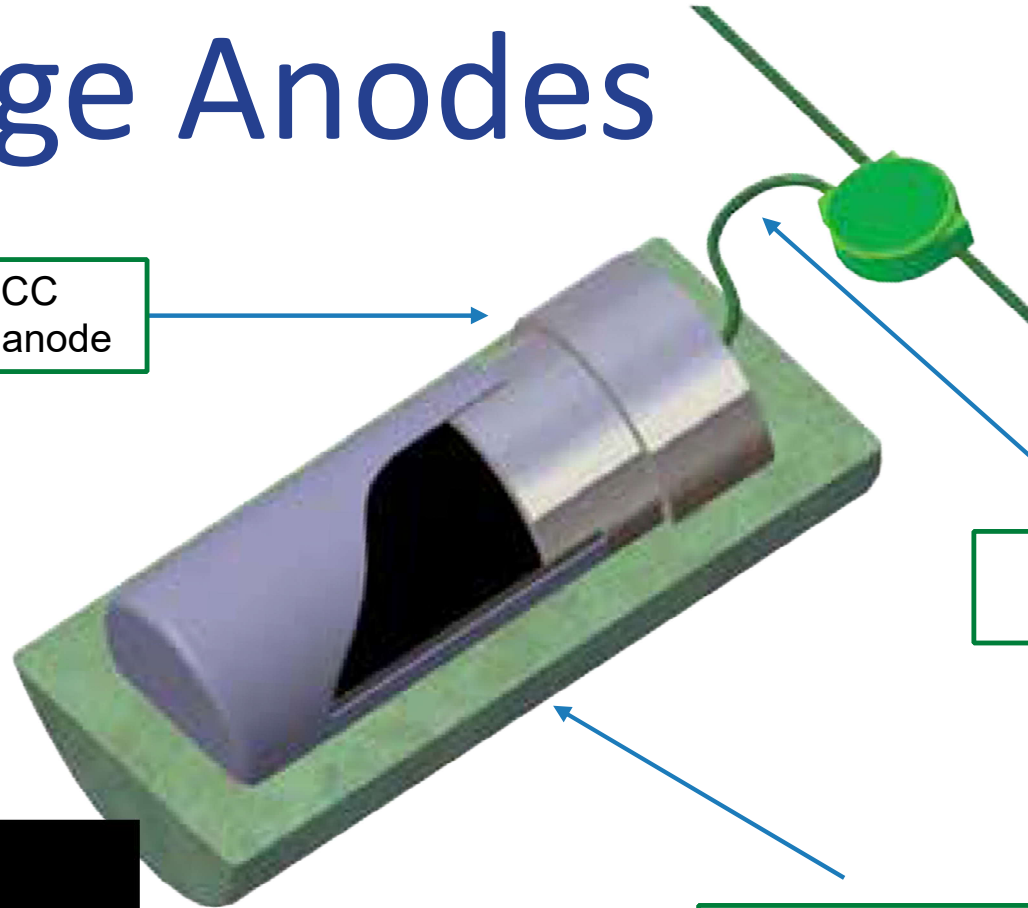
# Galvashield® Fusion™ T2 Two Stage Anodes

Galvashield CC  
alkali-activated anode

Single wire  
installation

Self-powered  
ICCP System

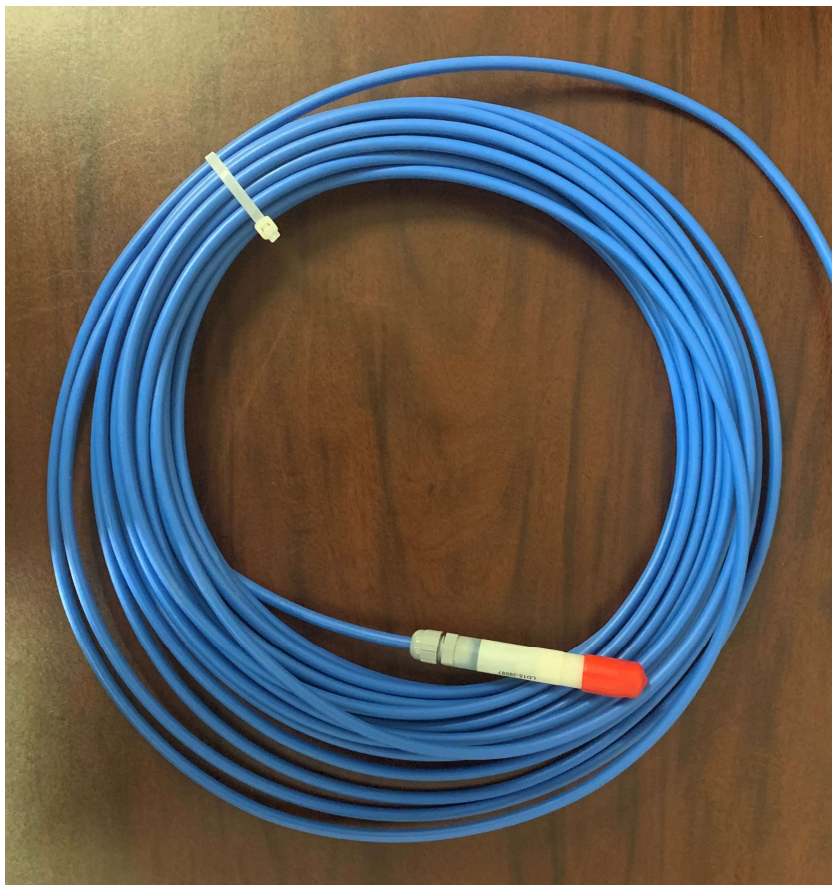
# Reference Electrodes

- Per the original plans test stations were required to monitor the performing of the zinc metalizing system
- Measured
  - Current from anode
  - Polarization with embedded reference electrode
- Embedded system utilized same test stations for monitoring performance

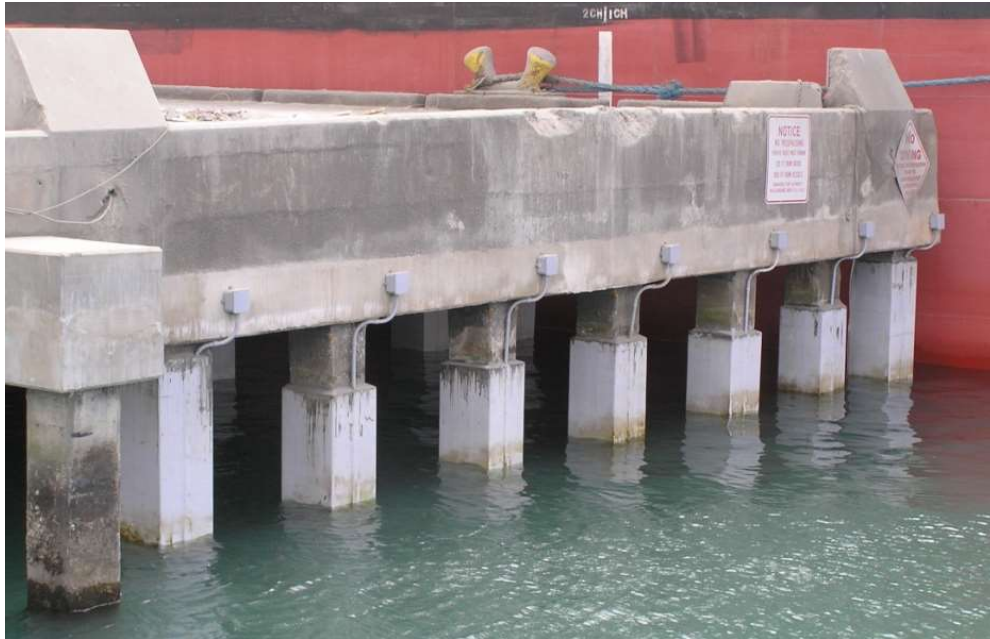
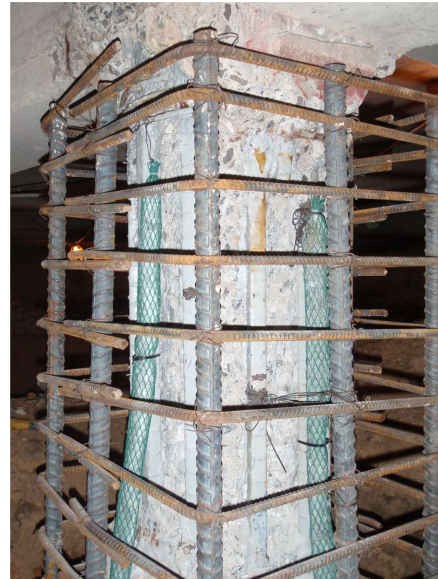
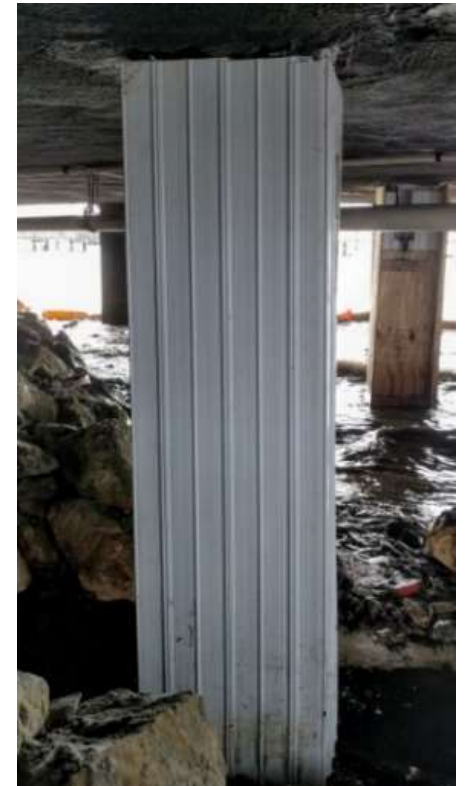
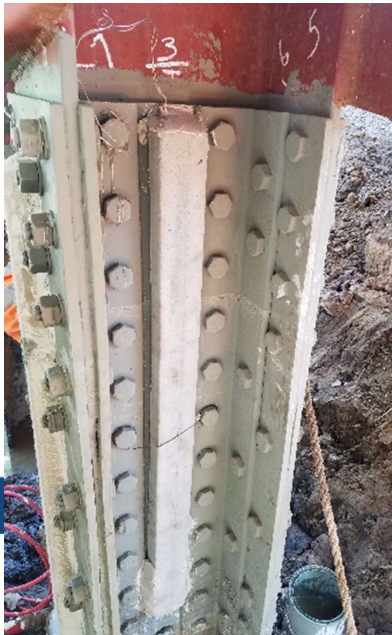
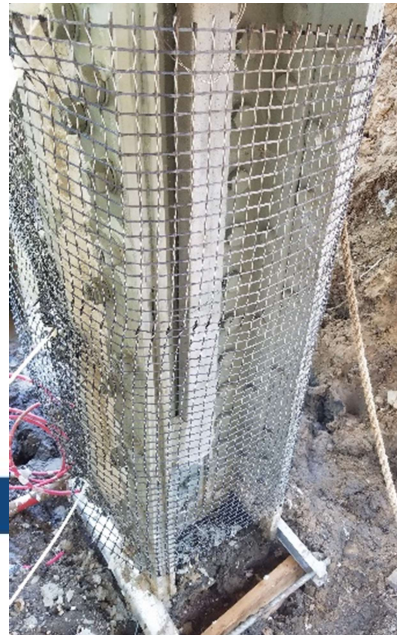
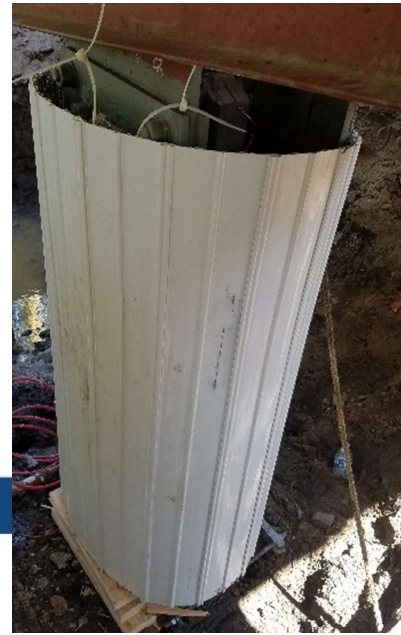
# Jackets

- Jacketing is the most common repair strategy
  - Critical to have cathodic protection in jackets
  - FDOT discovered accelerated corrosion in jackets without CP
    - Hartt, W.H. and Rapa, M., "Condition Assessment of Jackets Upon Pilings for Florida Bridge Substructures," Final Report, WPI No. 0510803, Florida Department of Transportation, Tallahassee, Florida, April 13, 1998
